BRADY'S RUN DAM

NDI I.D. NO: PA-257

PHASE I INSPECTION REPORT
NATIONAL DAM INSPECTION PROGRAM

(11) MAY 1979

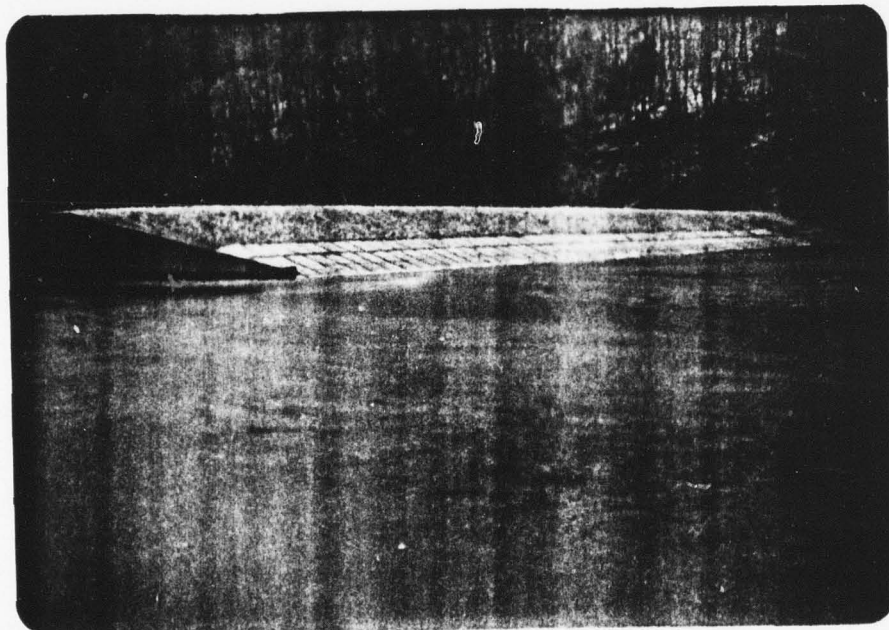
Upstream Face

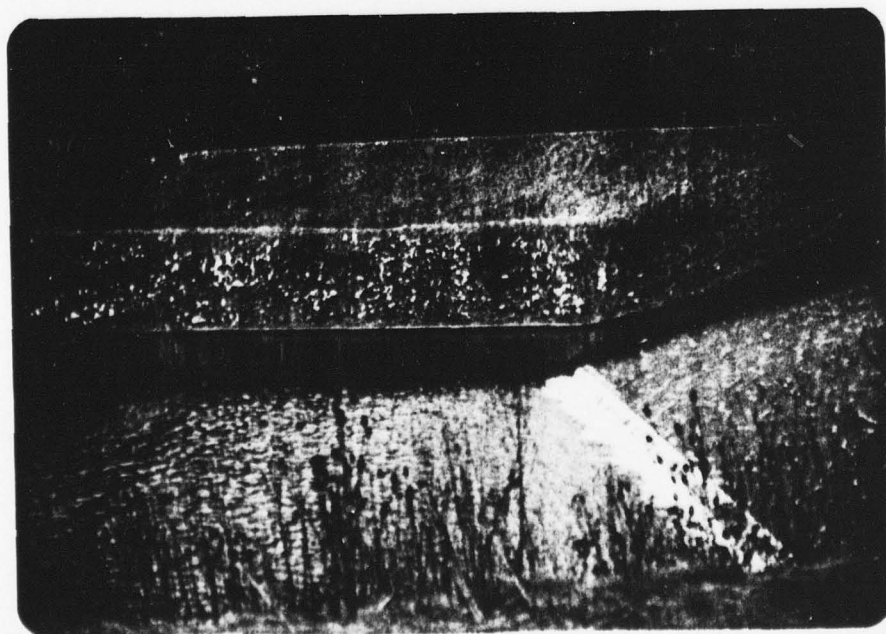
Downstream Face

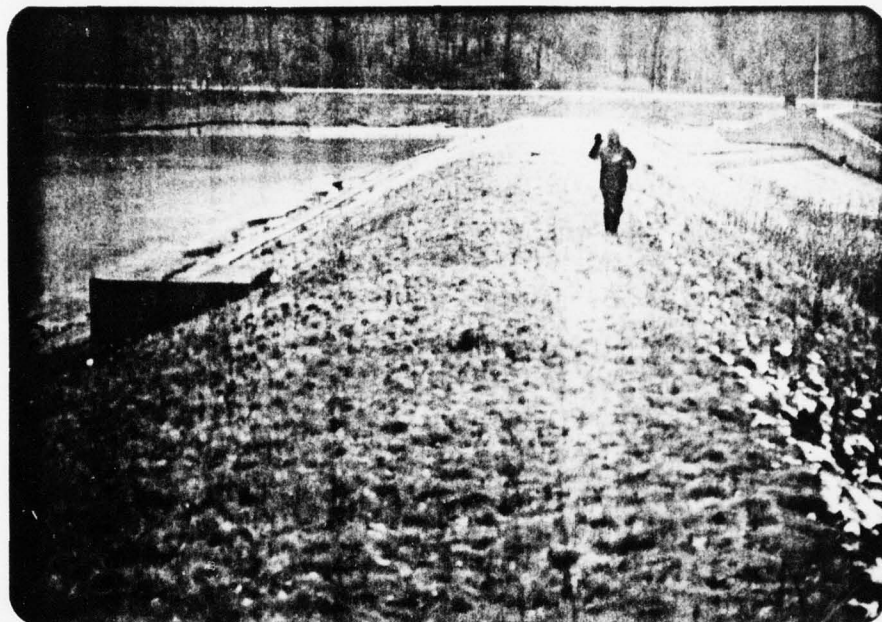
Photograph No. 1
Crest (looking north).

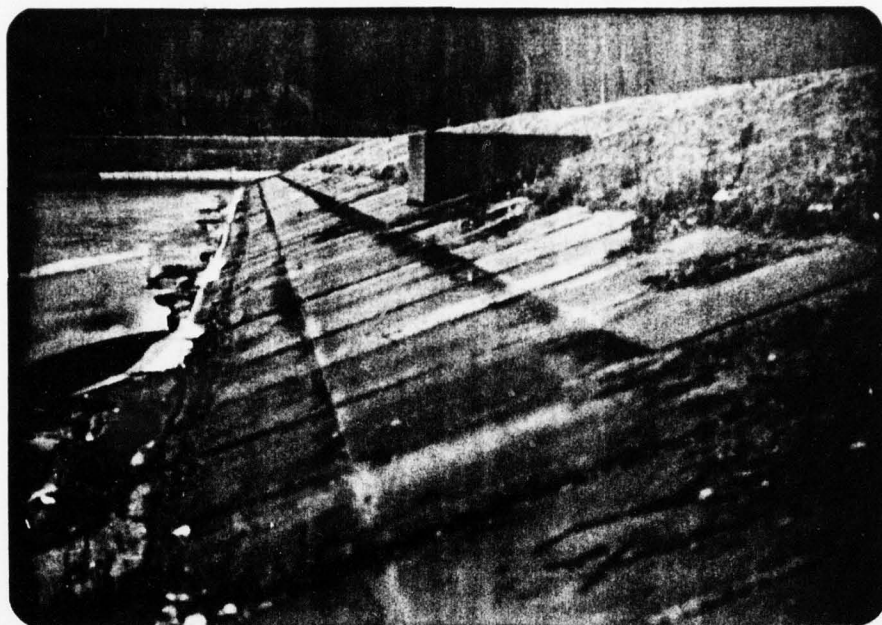
Photograph No. 3
Upstream slope protection.

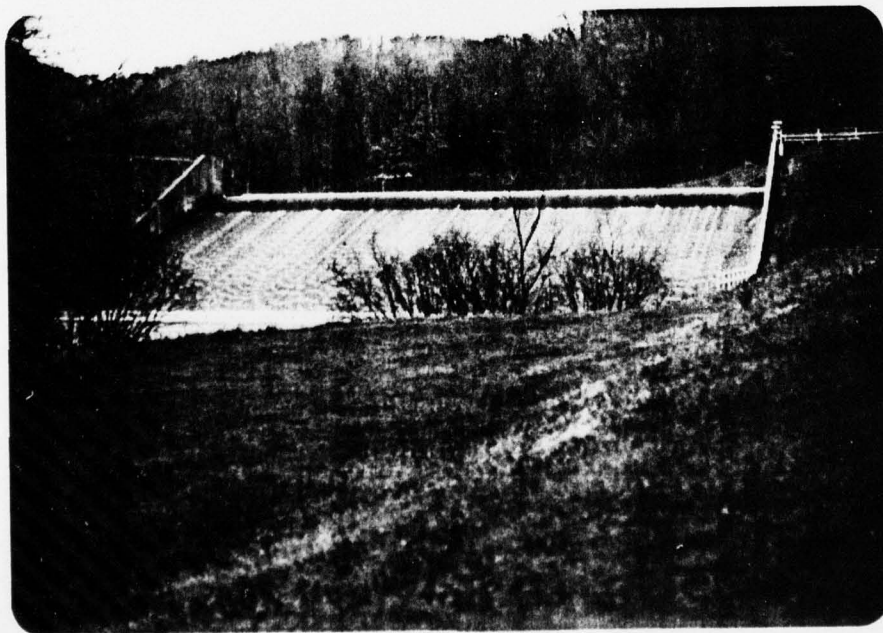
c. Appurtenant Structures. The appurtenant structures were examined for deterioration or other signs of distress and obstructions that would limit flow. In general, the visible portions of the spillway and the outlet works are considered to be in fair condition. Two structural cracks were observed at the construction joint of the right spillway walls. At the construction joint upstream from the spillway control section, the adjacent panels of the wall have separated and moved horizontally approximately one inch relative to each other.

The presence of two structural cracks in the right spillway wall and associated settlement of the embankment behind the walls raises some concern as to the continued stability of these structures. Necessary remedial work should be performed to avoid further structural distress and to insure continued stability of these structures.

Photograph No. 4
Spillway.

1. Necessary remedial work should be performed on the right spillway wall to avoid further structural distress and to insure continued stability of these structures.
2. Operational condition of the outlet works sluice gate should be evaluated and necessary maintenance performed.
3. Low spots on the embankment and erosion ditches on each side of the spillway chute should be filled.
4. Around-the-clock surveillance should be provided during unusually heavy runoff and a formal

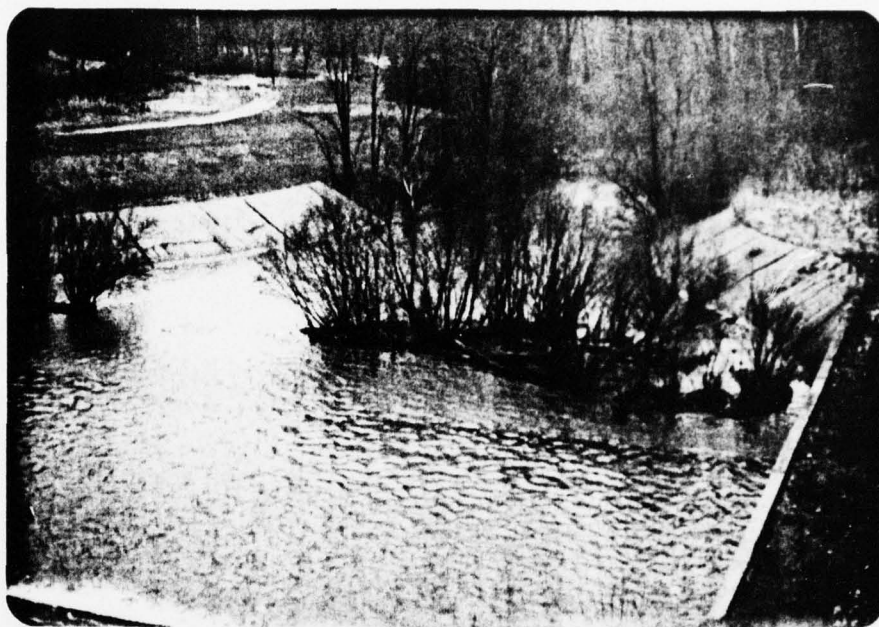
Photograph No. 5
Spillway, plunge pool.

5. The trees and brush should be removed from the spillway discharge channel.
6. The wet area on the embankment and the seepage points should be periodically observed to document if the conditions are changing.
7. The dam and appurtenant structures should be inspected regularly and necessary maintenance performed.

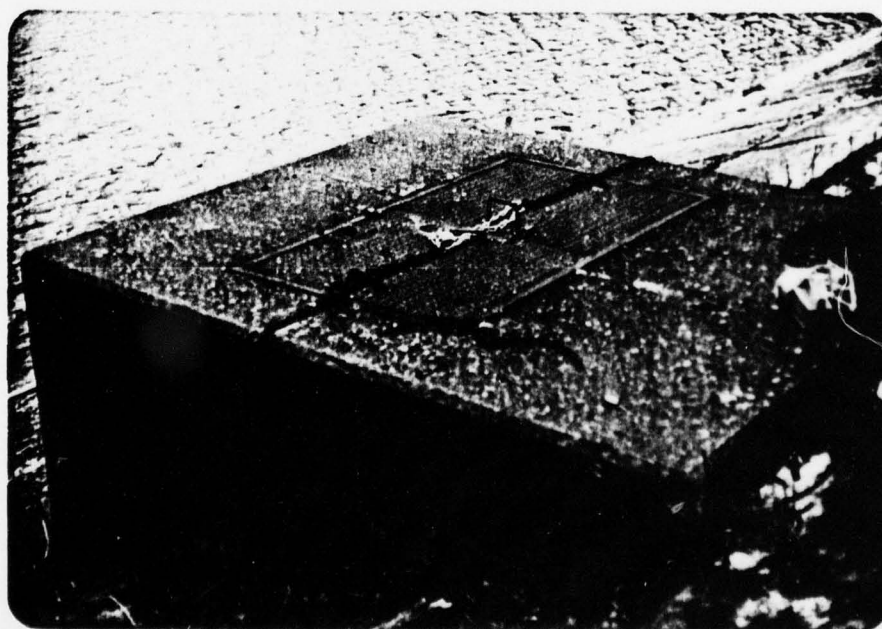
Beaver County personnel reported that, to their knowledge, the outlet conduit sluice gate has not been operated since the construction of the dam. The control tower access hatch has apparently jammed and could not be opened. Therefore, the operating equipment inside the control tower could not be observed.

Photograph No. 6
Blow-off conduit valve chamber.

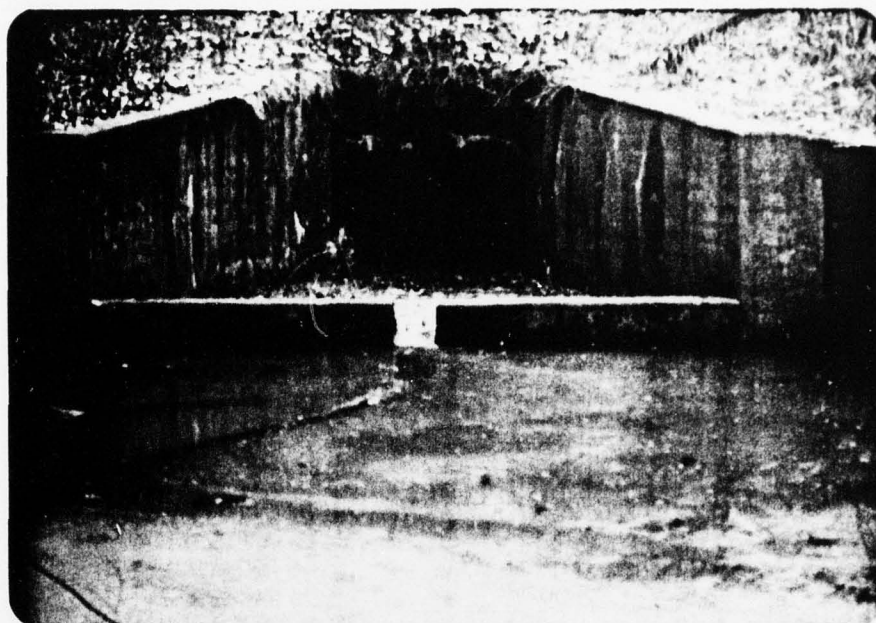
Photograph No. 7
Blow-off conduit and outlet structure.

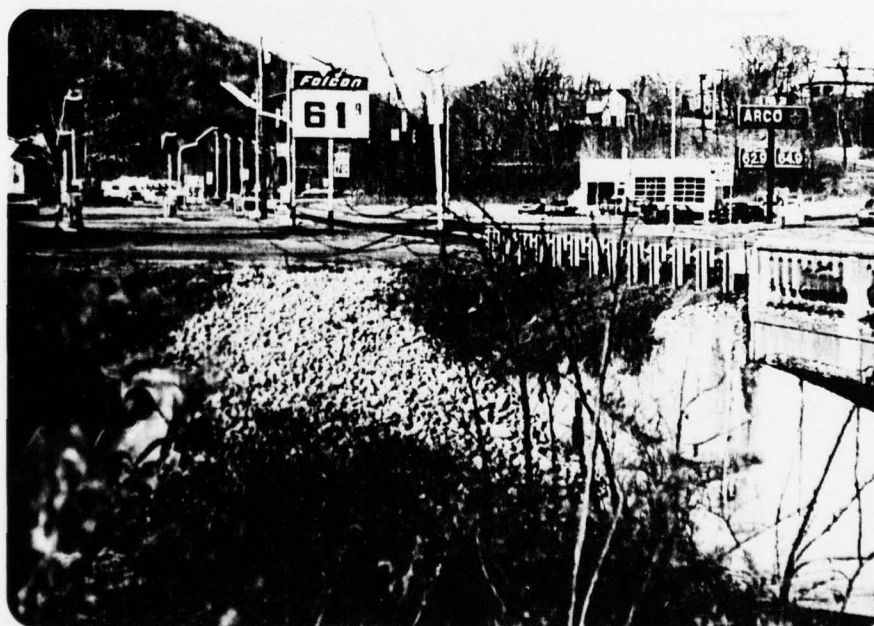
Photograph No. 8
Potential damage area about 3 miles downstream.
